CR 84.022

FIELD STUDY ON MOISTURE PROBLEMS IN EXTERIOR WALLS OF  
FAMILY HOUSING UNITS AT NAVAL AIR STATION PENSACOLA, FLORIDA

February 1984

An Investigation Conducted by  
H.R. TRECHSEL ASSOCIATES  
P.O. Box 211  
Germantown, MD 20874

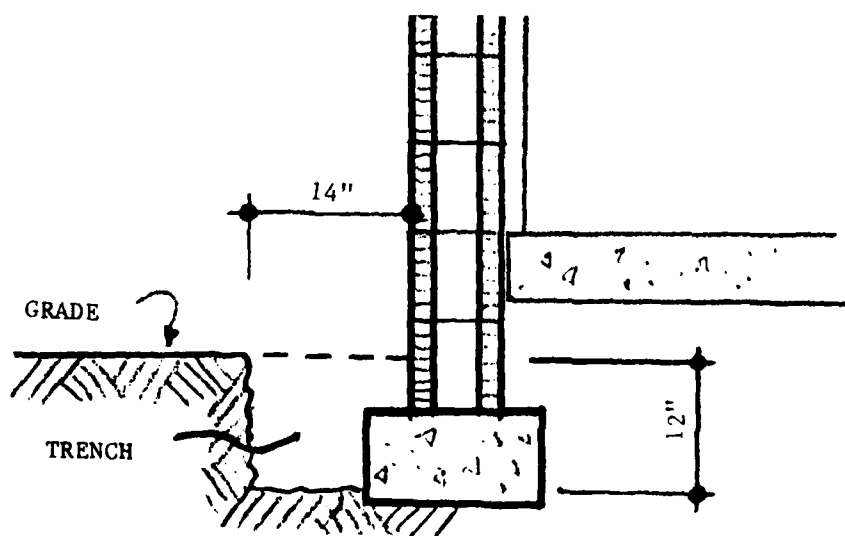
Figure 10. Trench at Footing

Because of a concern that water might leak into the concrete block cavities below grade, two approximately 10-foot trenches were dug in January along the wall and footing outside of Stations 1 and 3. One of the trenches was behind a rainscreen, and the other was not. The trenches were approximately 1 foot deep and 14 inches wide. The trenches exposed the footings and the block wall below grade (Figure 10). The wall and footing were then well cleaned, of dirt and loose debris.

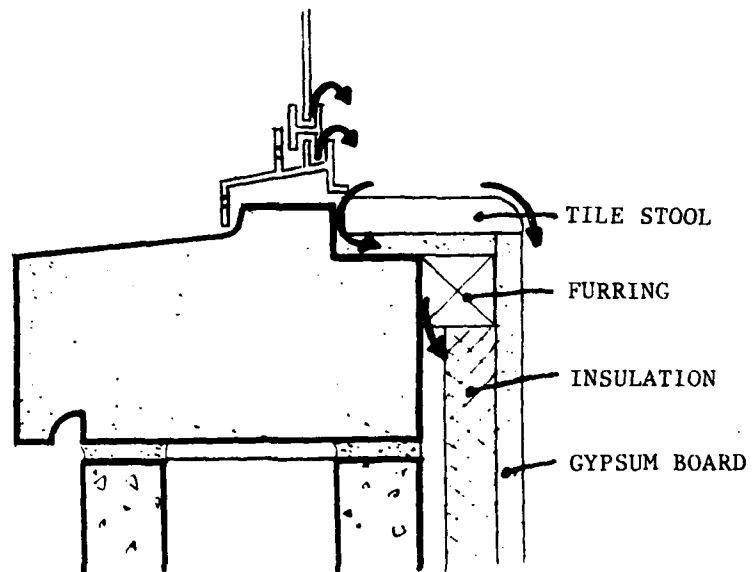
Figure 14. Leakage Paths of Water at Window Sill

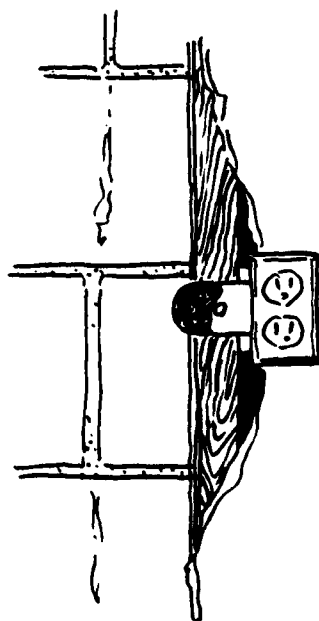
Figure 15. Rusted Mounting Bracket of Electric Outlet Near Leakage Site
